EROSION CONTROL DETAILS

EROSION CONTROL BLANKET

**McPHERSON**  
PUBLIC WORKS DEPARTMENT

SHEET: 14 OF 100

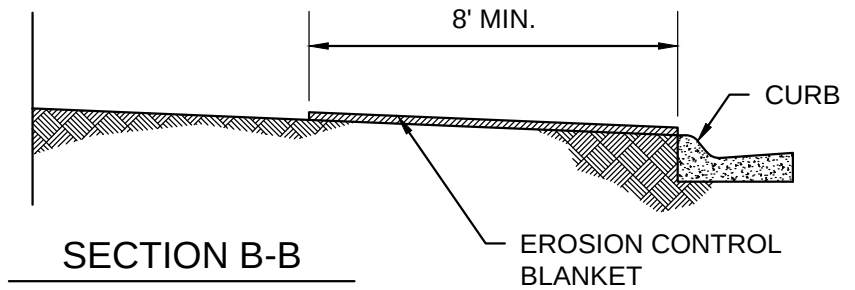
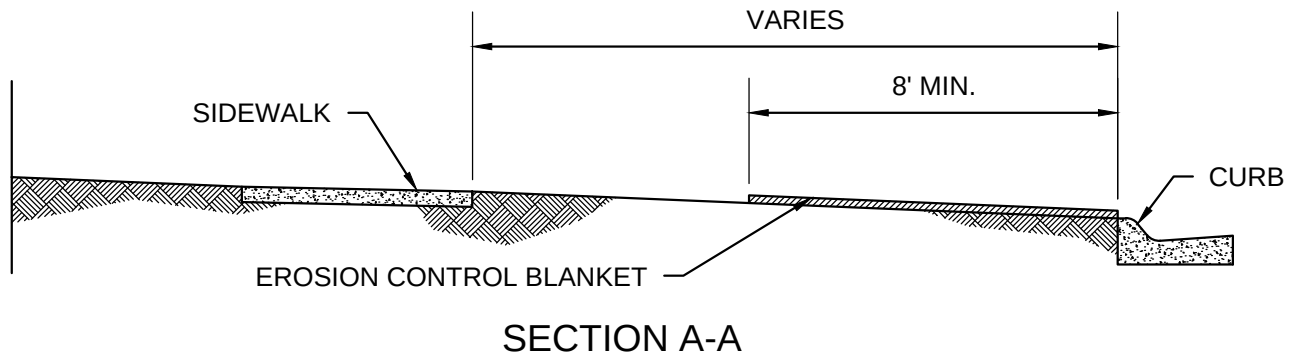
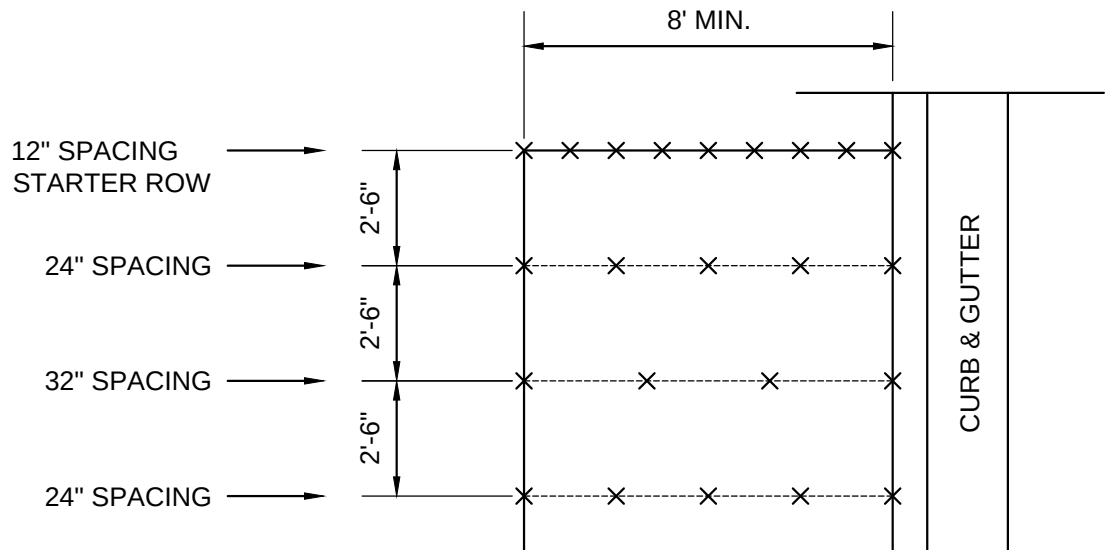
### STAPLE PATTERN

NOTE: OVERLAP SEAMS A MIN. OF 6"
